AAA Project No. 1696.02

**Re: Preliminary Facility Review and Study of North Huron Museum
273 Josephine St, Wingham**

Attached is **FINAL DRAFT** of Part A, Preliminary Facility Review and Study of North Huron Museum.

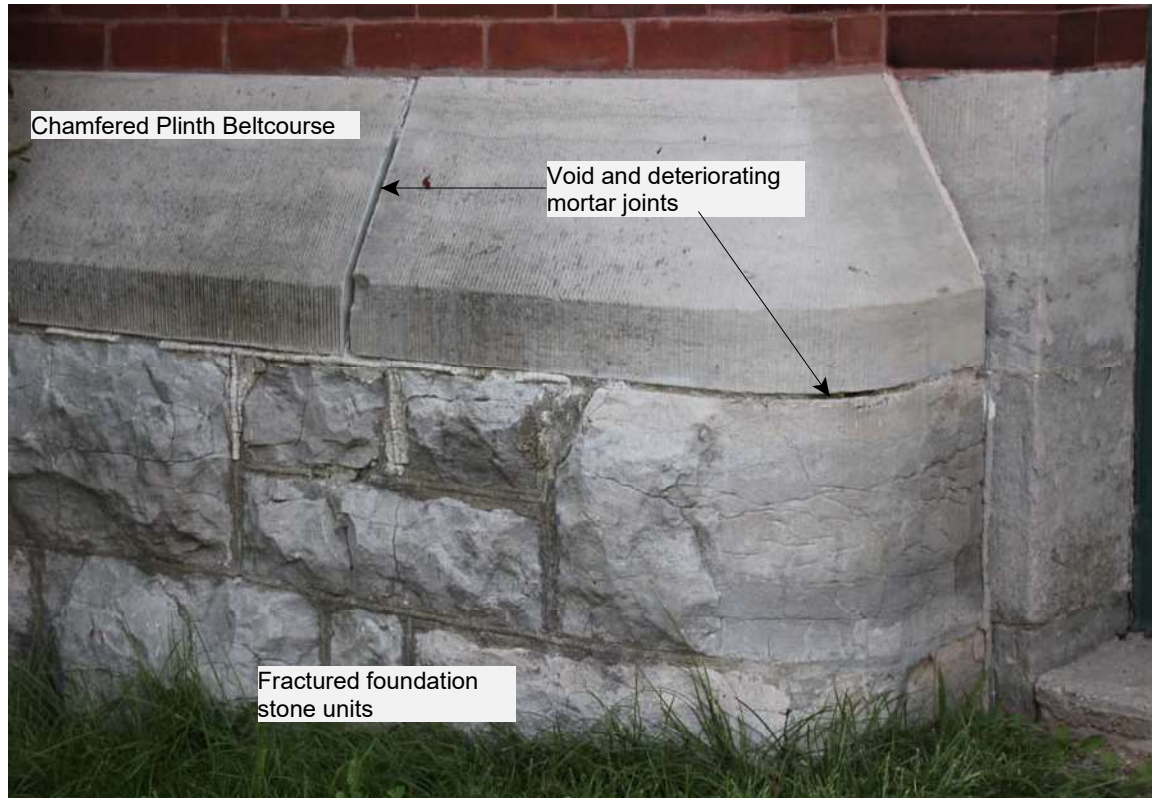
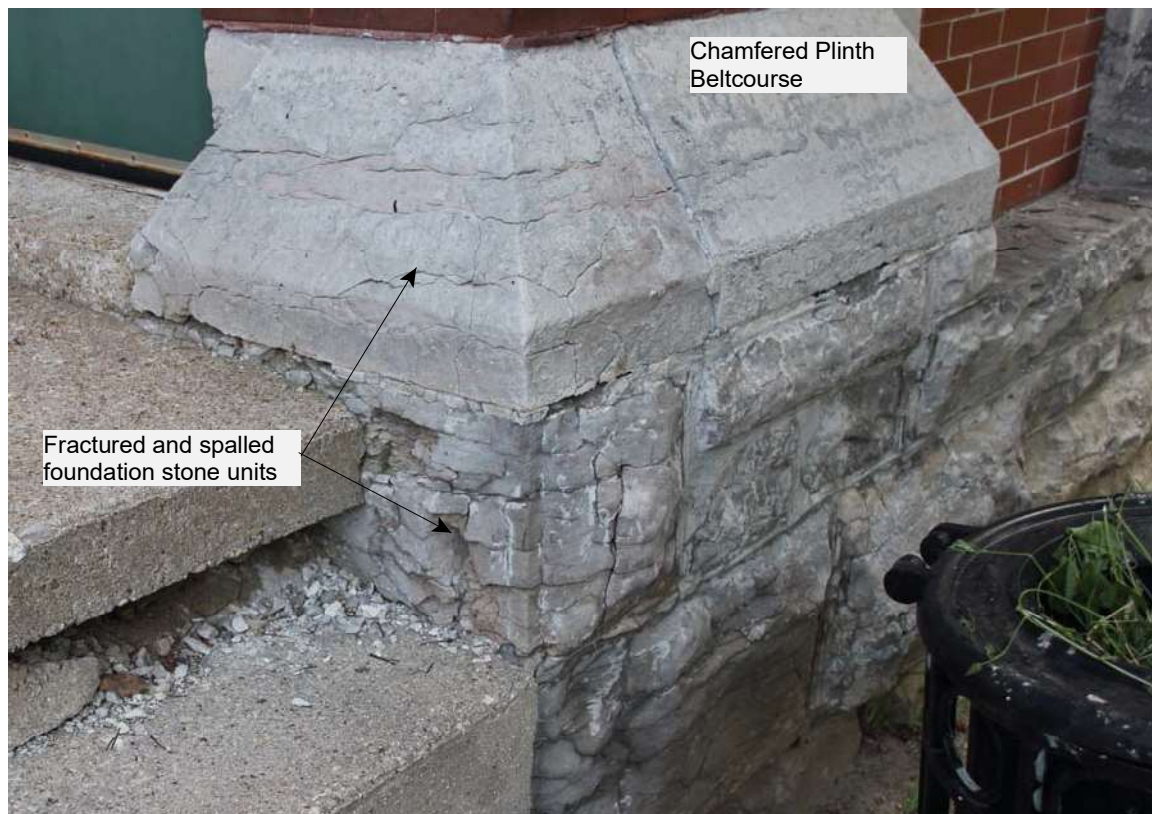
- ▶ Stone foundation is of coursed limestone units. Stone masonry appears to generally be in fair condition. Approximately 30% of foundation stone units have spalled faces, are severely fragmented and crumbling, and these stone units will require replacement or re-consolidation. This is most notable adjacent to stoops and sidewalks and at the chamfered plinth beltcourse, at transition between stone foundations and brick walls. Damaged and deteriorated stone units will require repair or replacement. Some mortar joints are severely weathered. It is anticipated that 100% of foundation mortar joints will require pointing. (Photographs are provided on following page)

| | Description | Budget Estimate |
|---|--|---|
| 2. | Exterior Masonry: - Repair/replace deteriorating foundation stone units and point 100% of foundation mortar joints. - Localized pointing of approximately 30% of mortar joints in exterior brick masonry walls. - 100% pointing of chimney masonry and install new sheet lead cap. | \$412,000 |
