## SITE VISIT REPORT

| Name of Project: | Blyth Memorial Community Hall<br>Attic Investigation | Project No.: 1727 |
| Location: | 431 Queen Street, Blyth, Ontario | Report No.: 01 |

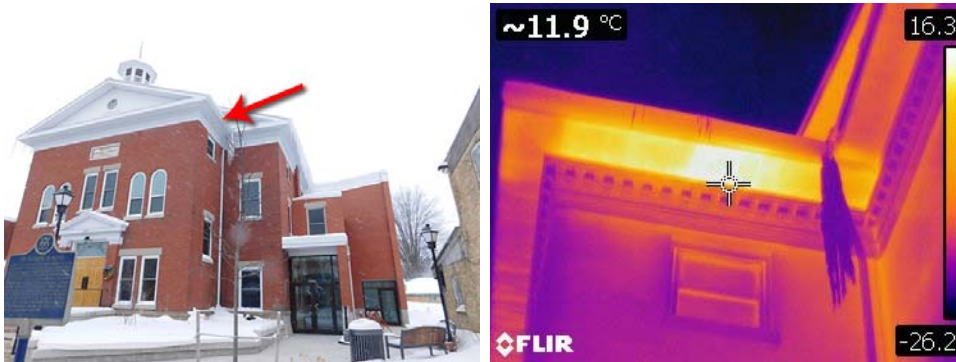
- 1.2 The exterior of the building was reviewed, revealing one area with noticeable heat loss. The area of soffit on the north side of the A/V Control Booth was recorded at 11.9°C. This area of the soffit is in the same area reported to have large icicles and ice damming, causing damage to the gutter and downspouts. Icicles are shown in the photos below. It was reported by the General Contractor, who completed recent renovations in the building, that the exhaust fan from the A/V Control Booth does exhaust directly into this vented soffit area.

2. Reroute exhaust duct from exhaust fan installed in the ceiling of the A/V Control Booth. Provide new insulated and sealed duct, routed to a new storm-proof louvre, installed in east gable, located out of view, behind the bell tower cupola.

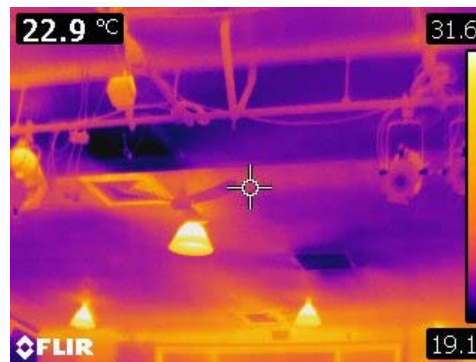
- 1.3 The ceiling of the Upper Hall was reviewed and scanned with the thermography camera. There were no concerns, such as cold zones, indicating missing insulation, or areas where large amounts of air-leakage were occurring. Thermography scans indicated a relatively even temperature gradient over the entire ceiling.

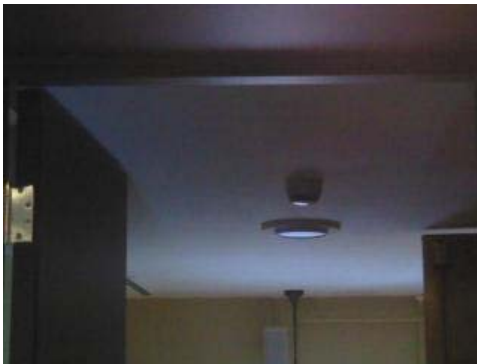
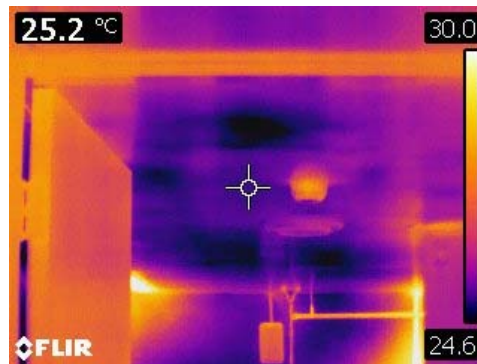
- 1.4 The Balcony Level, in the East Exit Stair, adjacent to the A/V Control Booth, was reviewed. This area was noticeably warm and had an ambient temperature of 33.6°C. AAA was made aware of issues with the HVAC system in this area, prior to the site visit, so the result was not unanticipated. In this same stairwell, the ground floor level temperature measured 8.6°C. Thermography scans of the ceiling indicated cold areas in the centre of the ceiling. Investigations in the attic revealed that mechanical ducts and sprinkler lines, interrupting the continuity/thickness of the attic insulation, were the likely cause of these cold areas. Additional insulation could be added in this area, but these cold zones (areas of heat loss into the attic) are not suspected to be a primary cause or a contributing factor of the snow melting on the roof of the building.

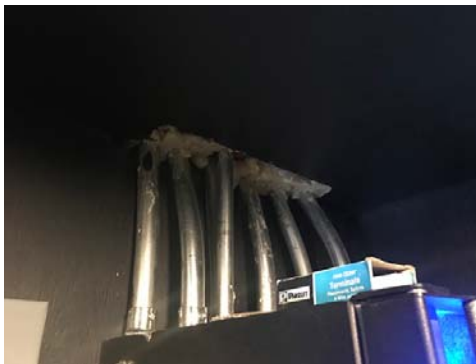
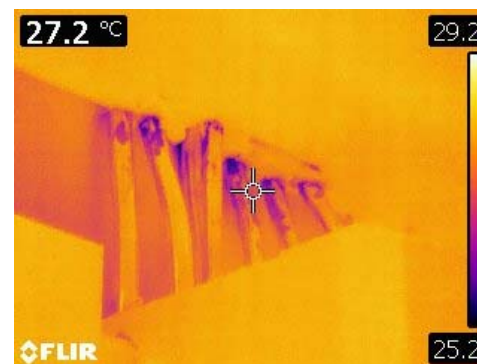
- 1.5 The A/V Control Booth was reviewed and was found to generally have good air sealing around electrical and data conduits, penetrating through the ceiling. The ceiling-mounted exhaust fan was running in this room the entire time of the visit, in order to extract the heat generated by lighting dimmer racks and other electrical equipment in the room.

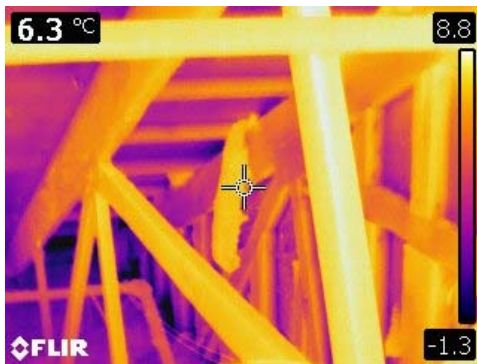
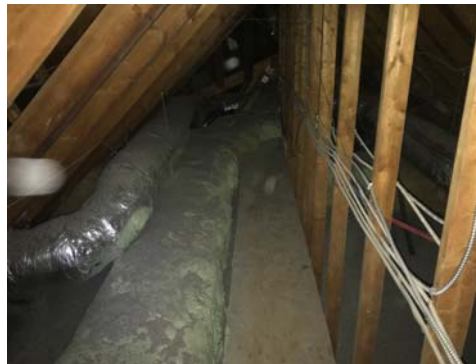
- 1.6 The attic space was reviewed and found to be relatively warm. The temperature at the time of the review fluctuated between 6-8°C. The temperature of the underside of the roof sheathing, at the midpoint of the roof slope, was 4°C. The temperature at the underside of the roof sheathing, above the insulated supply-air duct, located in south east corner of attic was 14°C. Therefore, melting of snow on the roof would occur in all of these locations, especially above the supply-air duct in the south east corner of the attic. This duct location is also an area where heavy ice damming and icicles were reported, and were visible on the exterior of the building during this review (although to a lesser degree than what had previously occurred). This duct and the duct opposite in the attic are existing to the building and not part of the 2017 renovation project.

6. Install storm-proof louvres in the west gable, located above lower gable roof to the west, in order to increase attic ventilation.
7. Temporarily remove the vented soffit around the area of supply air ducts, located in the southeast and northeast corners of the attic. Once accessible, the insulation around the ducts will need to be reviewed and options explored to create an airspace between the top of the duct/insulation and the underside of roof deck. The reason is to provide free movement of outside air from the soffit area into the attic. It may be found that the duct needs to be modified in order to create enough airspace. Further review and consideration is required.

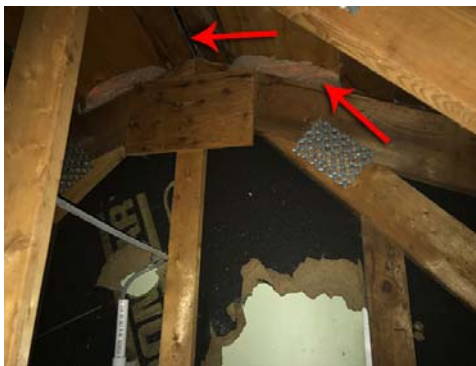
- 1.7 During review of the west gable end of the attic, fiberglass batt insulation was found packed into many gaps between the roof strapping and extending out beyond the gable, forming the roof overhang. We assume this batt insulation is existing and was installed to stop wind-driven snow from entering the attic. The batt insulation decreases airflow from the vented soffit into the attic. The continuous ridge flashing, at roof peak, is not vented and it is our understanding that this was installed during the roofing of the 1990 renovation project. Red arrows, in the image below, point to the batt insulation between strapping and at the non-vented ridge flashing.

1. Replace existing ridge flashing, on the main upper roof of Memorial Hall, with continuous vented ridge flashing. This will help increase ventilation and the "change-over" of air in the attic.

3. Remove batt insulation from gaps between strapping in west gable. Install fibrous mesh venting material (mortar net) to allow greater air movement/ventilation and reduce wind-driven snow from entering attic.

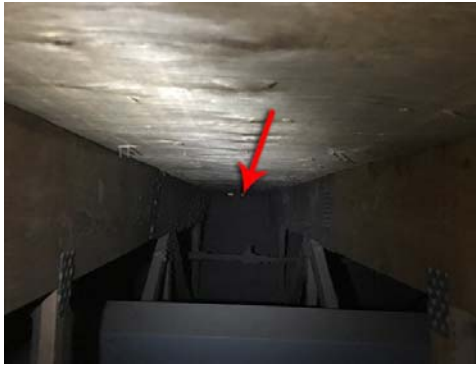
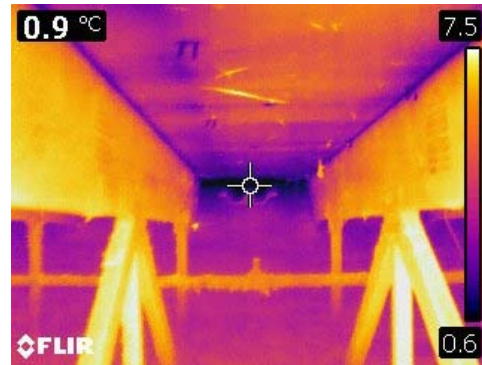
- 1.8 The typical eave condition, at the heel/base of the trusses, had insulation baffles (1'-0" wide) centred in each truss space. In most locations, the baffles were compressed and the loose-fill cellulose insulation was tight to the underside of the roof sheathing. Both of these factors will restrict airflow into the attic. The temperature of the sheathing, just above the insulation baffles, located at the heel of the truss, was approximately 1°C, as shown in the below image.

4. Rake-back the loose-fill cellulose insulation and create an air gap at the truss heel location, between the top of insulation and the underside of roof sheathing. This will allow free air movement from the soffit into the attic and keep the sheathing and roofing cooler, thereby, reducing snow melt.

5. If the cellulose insulation cannot be adjusted from within the attic, to create an air gap, per item 4, temporarily remove the soffit from the exterior and install plywood baffles in each truss space, providing a minimum 1½" airspace below the roof sheathing, allowing free air movement from the soffit to the attic.
