AAA Project No. 1696.02

**Re: Preliminary Facility Review and Study of North Huron Museum
273 Josephine St, Wingham**

Attached is **FINAL DRAFT** of Part A, Preliminary Facility Review and Study of North Huron Museum.

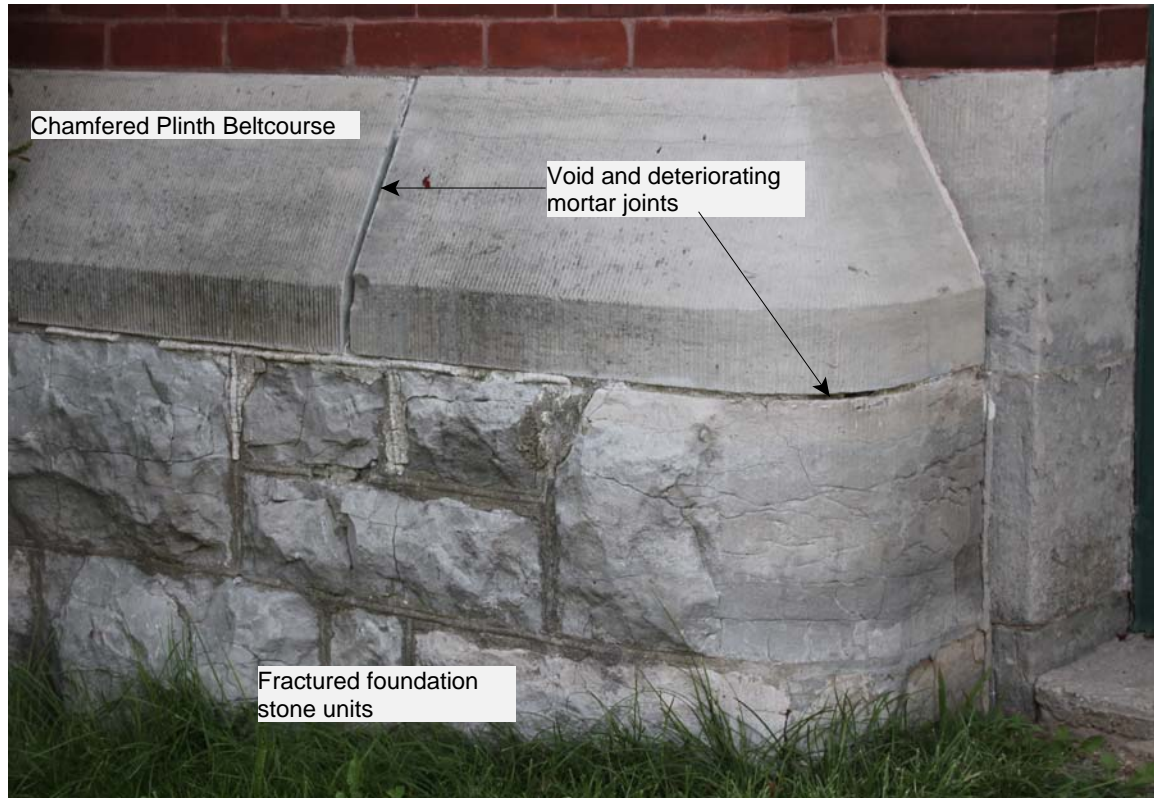
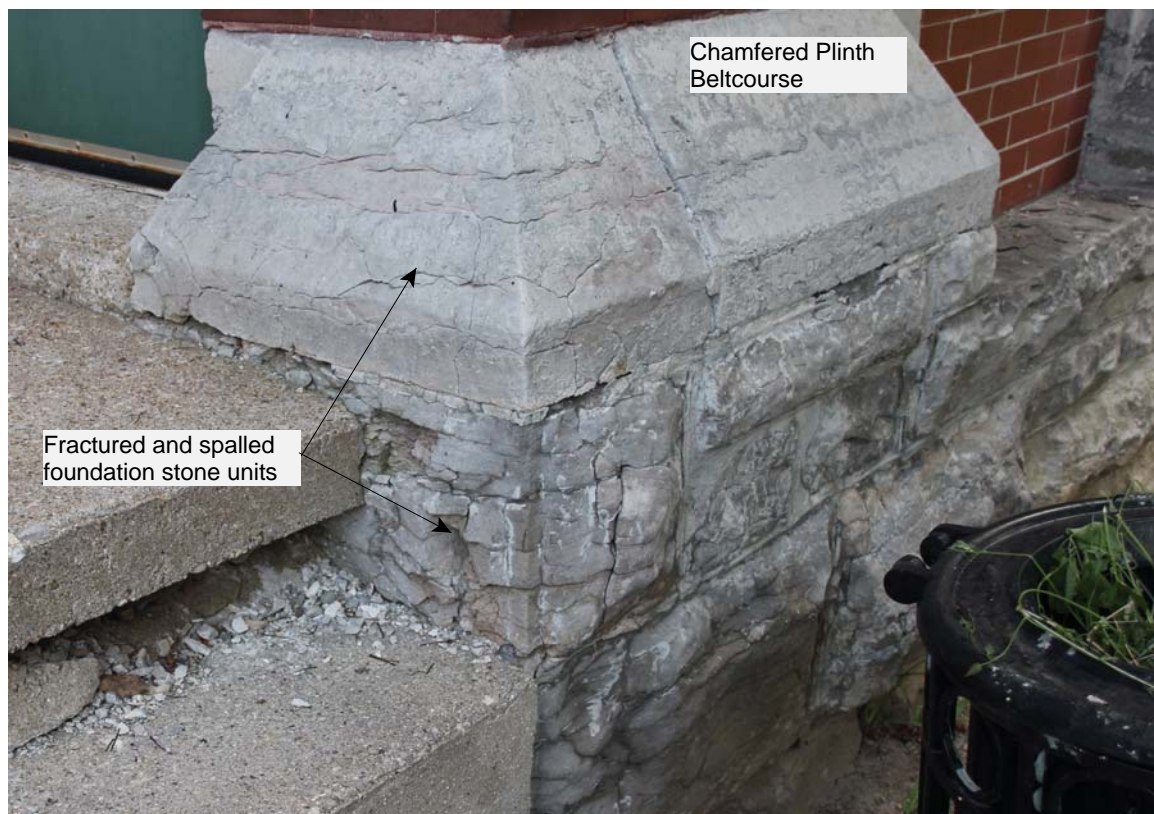
- ▶ Stone foundation is of coursed limestone units. Stone masonry appears to generally be in fair condition. Approximately 30% of foundation stone units have spalled faces, are severely fragmented and crumbling, and these stone units will require replacement or re-consolidation. This is most notable adjacent to stoops and sidewalks and at the chamfered plinth beltcourse, at transition between stone foundations and brick walls. Damaged and deteriorated stone units will require repair or replacement. Some mortar joints are severely weathered. It is anticipated that 100% of foundation mortar joints will require pointing. (Photographs are provided on following page)

2.	Exterior Masonry: - Repair/replace deteriorating foundation stone units and point 100% of foundation mortar joints. - Localized pointing of approximately 30% of mortar joints in exterior brick masonry walls. - 100% pointing of chimney masonry and install new sheet lead cap.	\$412,000
