EVALUATION OF EXISTING  
MAIN HOWSON DAM  
BRIDGE STRUCTURE  
OVER MAITLAND RIVER ON WATER STREET  
IN THE TOWN OF WINGHAM

BR-476

TOWN OF WINGHAM  
REPORT ON EVALUATION  
OF EXISTING MAIN HOWSON DAM AND BRIDGE  
OVER MAITLAND RIVER ON WATER STREET

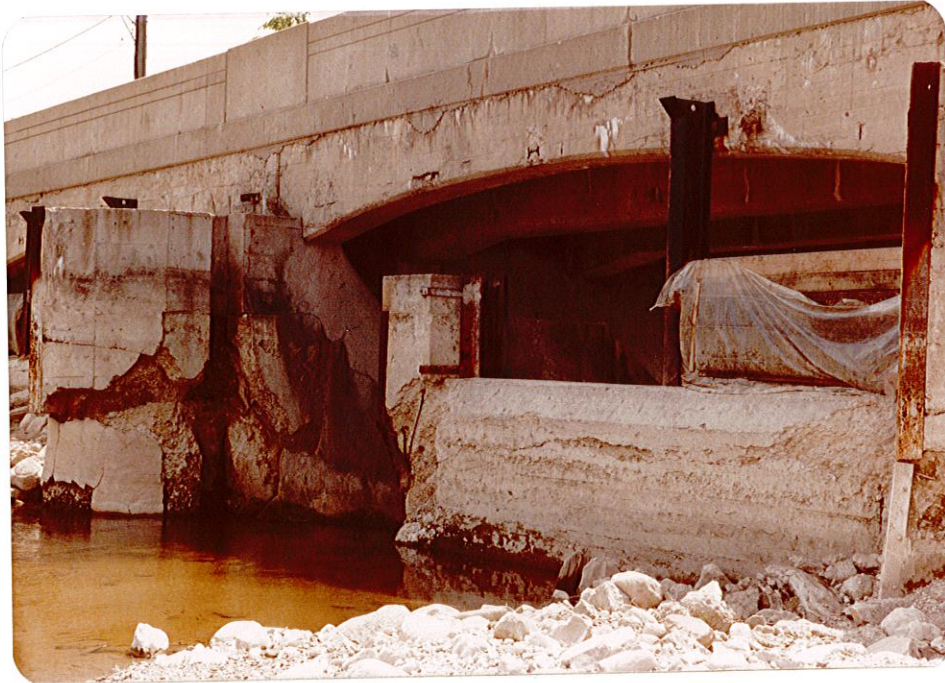
to sections of the deck supporting beams as well as the sub-structure. Pictures (i) and (ii) in the back of the Appendix are indicative of the upstream spalled concrete surfaces of the sub-structure. Pictures (iv) and (v) show the spalling of the outside downstream beam of spans two and three from the north abutment.

BR-476 - (i) - Upstream East Elevation  
Third Span from North

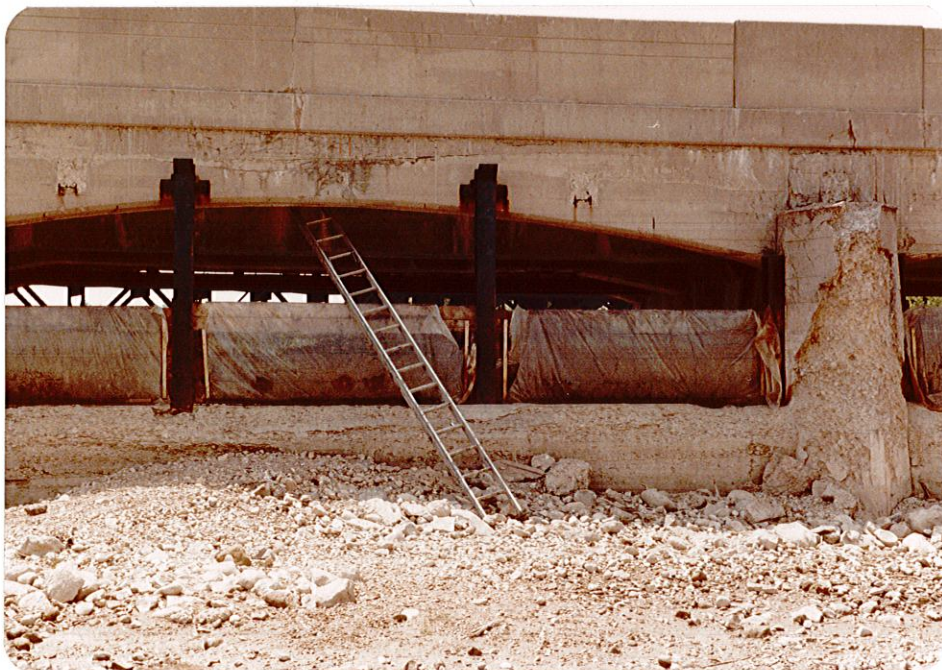
BR-476 - (ii) - Upstream East Elevation  
Second Span from North

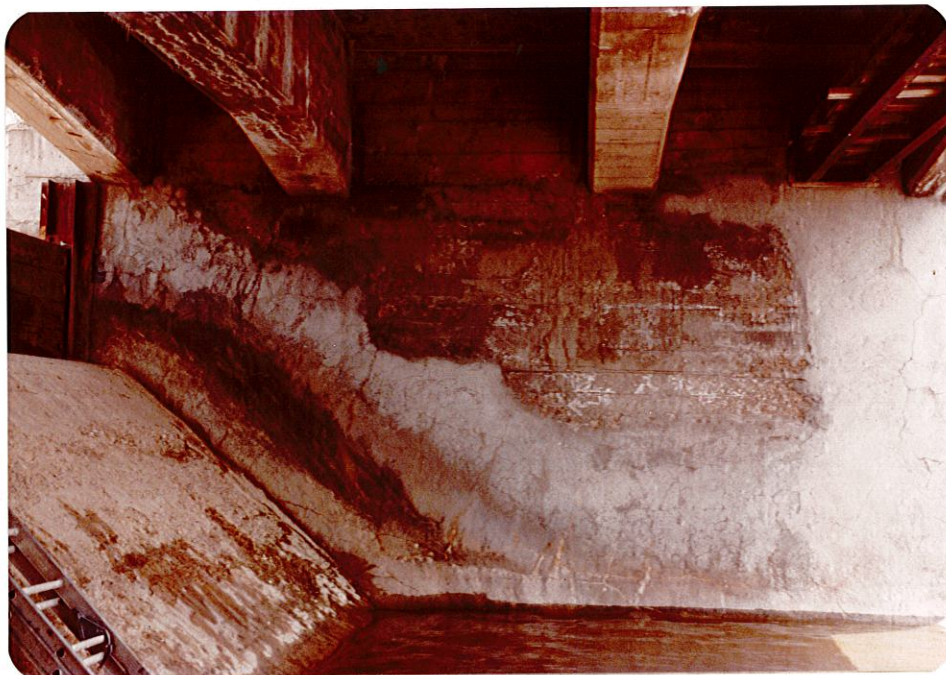
There is evidence of considerable leaching of chloride through the porous concrete of the deck, beams and sub-structure. While this is shown in many of the photographs enclosed, it is particularly evident in photos (iii), (vi) and (vii).

BR-476 - (iii) - North Face of Pier No. 2 from  
North Abutment

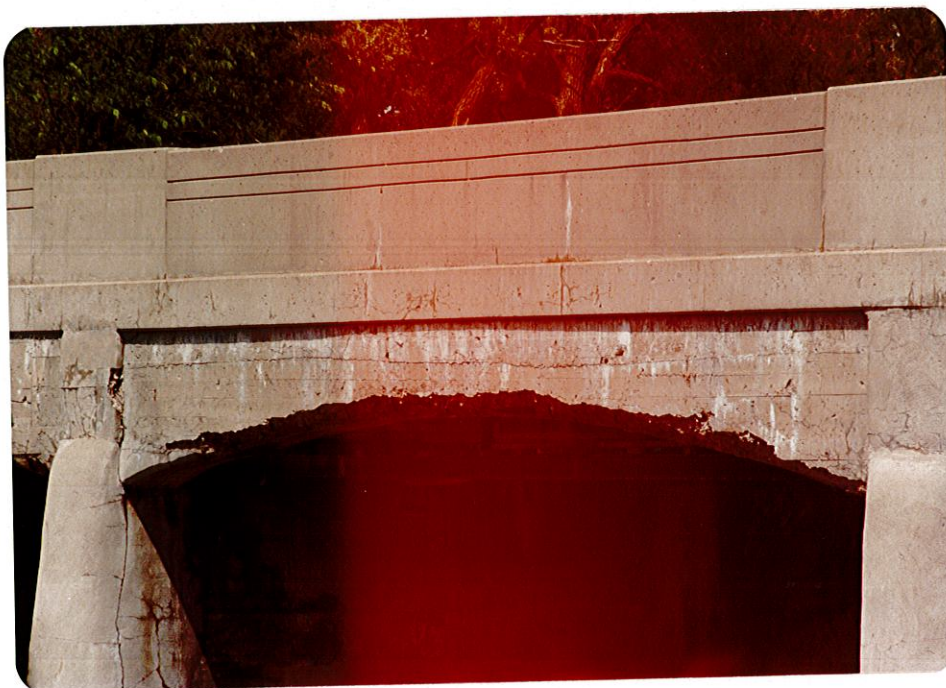
BR-476 - (iv) - West Elevation Second Span from  
North Abutment

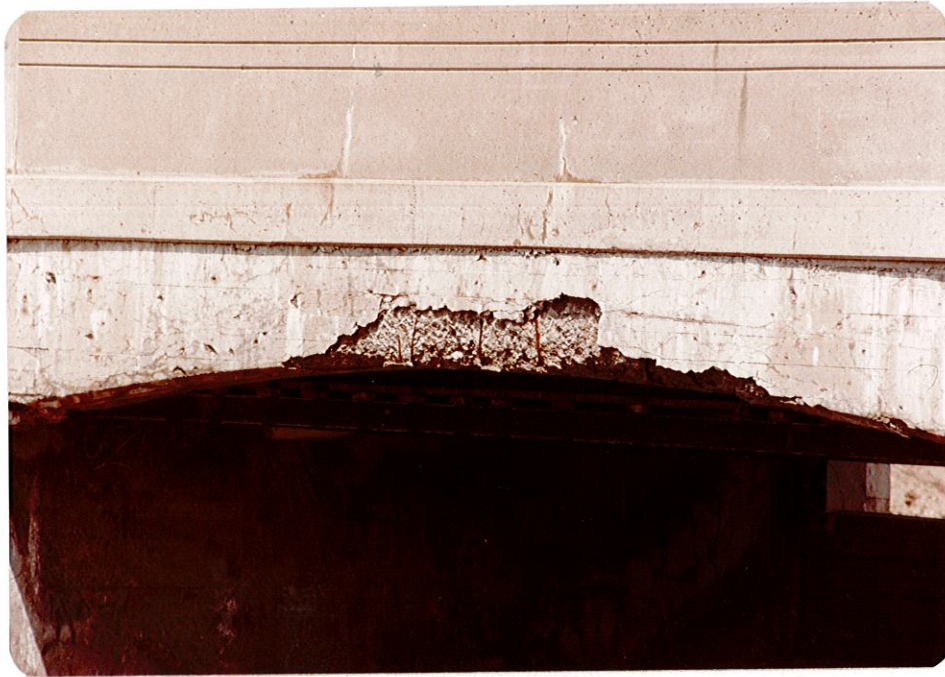
BR-476 - (v) - West Elevation Third Span from  
North Abutment

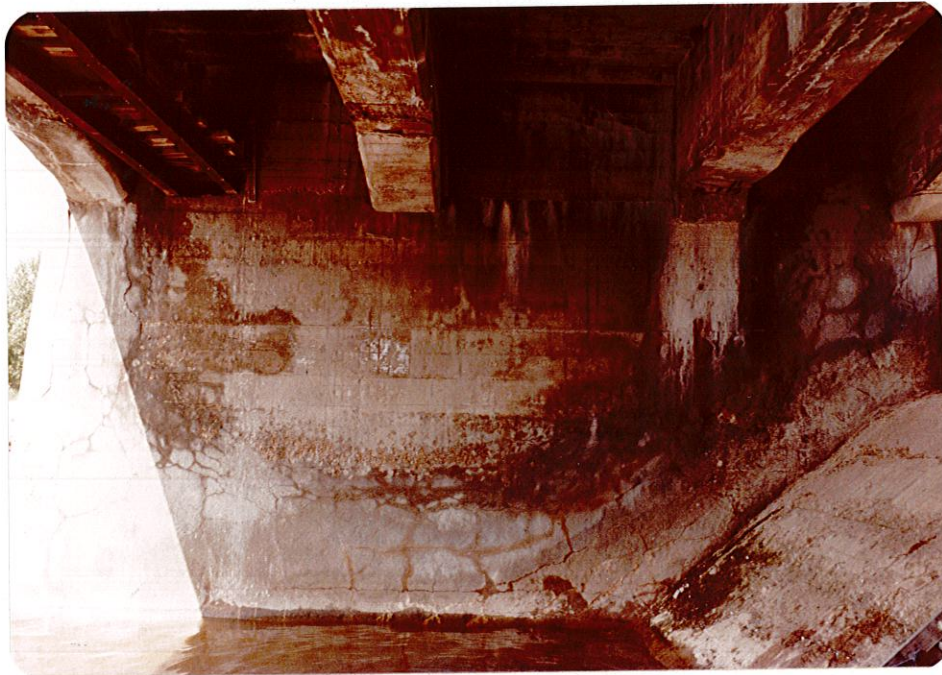
BR-476 - (vi) - South Face of Pier No. 1 from  
North Abutment

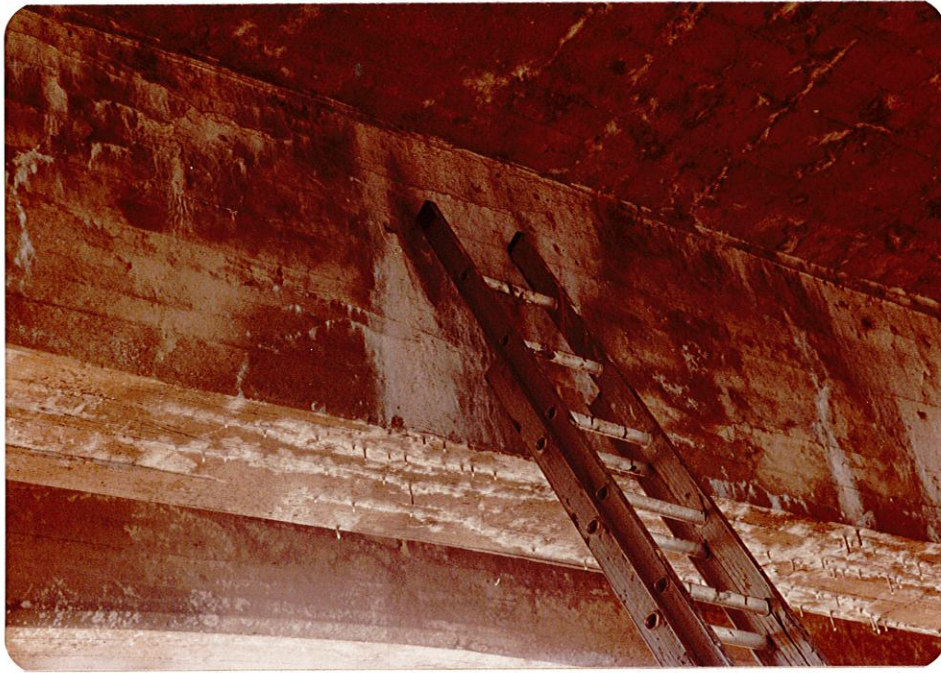
BR-476 - (vii) - West Face of First Beam East of  
Centreline Roadway - Second Span  
from North Abutment

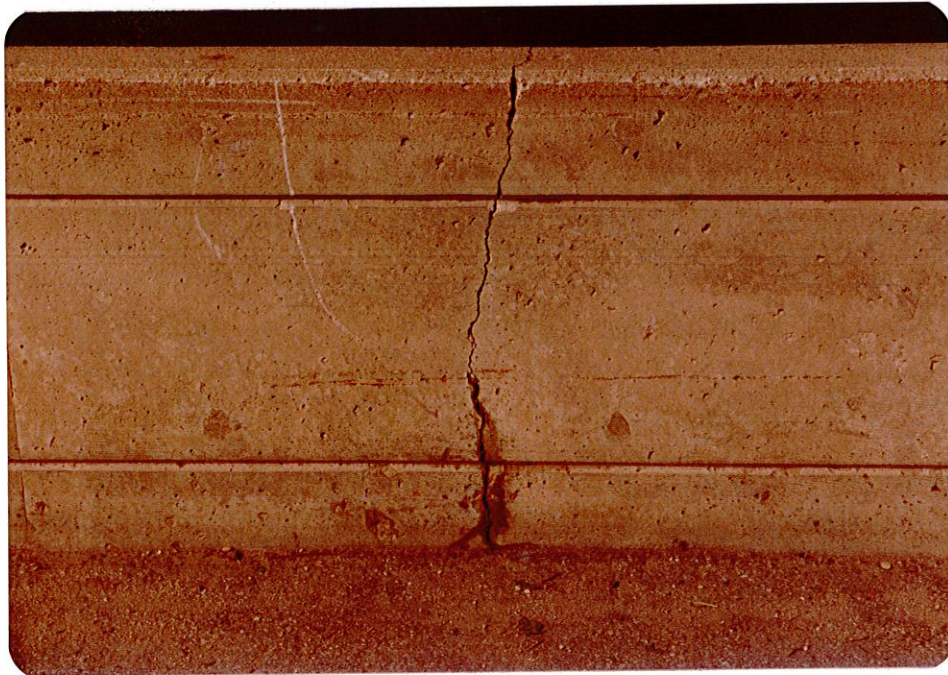
There are severe signs of deterioration with spalling and cracking in the super-structure. There is a pattern of vertical cracking in the concrete headwall handrails. The majority of these cracks are located either at the one-third point of the spans or at the mid-span. Normally such cracking occurs over the piers and is caused by tension as a result of settlement at the centreline of the span. The location of these cracks would normally be caused by tension from uplift of ice on the underside of the deck. One other possible explanation for the location of these cracks may be due to the fact that the top of the beams supporting the stop log at the one-third point is now held by the side of the deck. If in the past the stop log and supporting beams were left in under severe flooding conditions, this could have resulted in the cracking of the handrail. An example of the typical cracking is shown in Picture (viii) and is located in the west handrail at the two-thirds point of the first span

BR-476 - (viii) - Crack through West Handrail at  
Two-Thirds Point of First Span  
from North Abutment

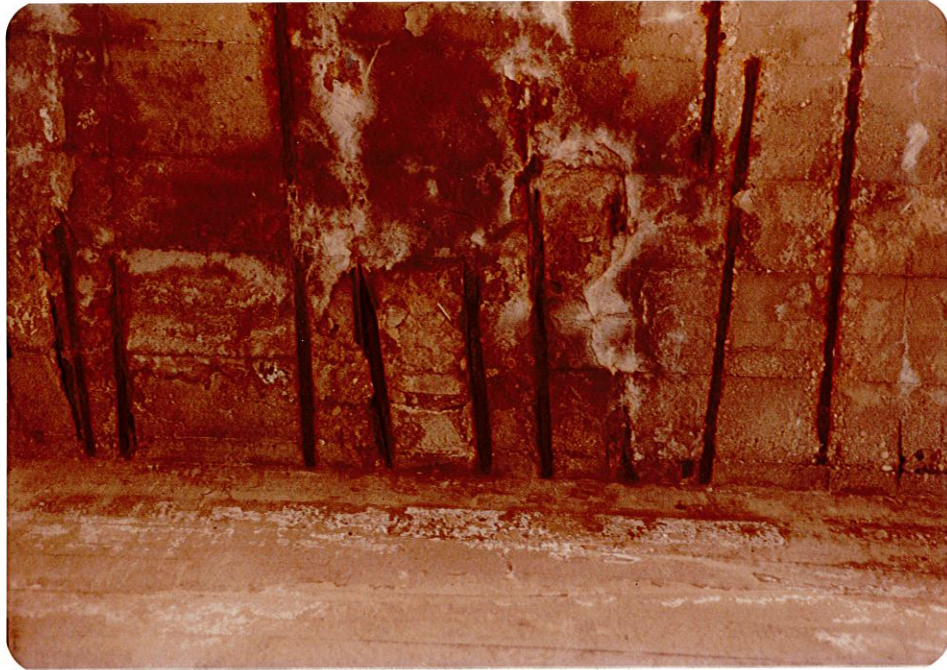
The underside of the concrete deck is in fair condition with areas of surface spalling and delamination. There was also considerable evidence of leaching of chlorides through the deck. It was impossible to inspect the upper surface of the concrete deck with the presence of the 75 mm thickness of asphalt. From the core samples that were taken through the roadway section of the deck, the thickness is approximately 280 mm (11 inches) and not the 200 mm (8 inches) shown on the original plans. One of the poorer areas showing the spalling of the underside of the deck and the exposed reinforcing is shown in Picture (ix) and is between the first beam east of the centreline of the road and the outside east beam of the second span from the north abutment.

BR-476 - (ix) - Underside of Deck Between First Beam  
East of Centreline and Outside East  
Beam - Second Span from North Abutment

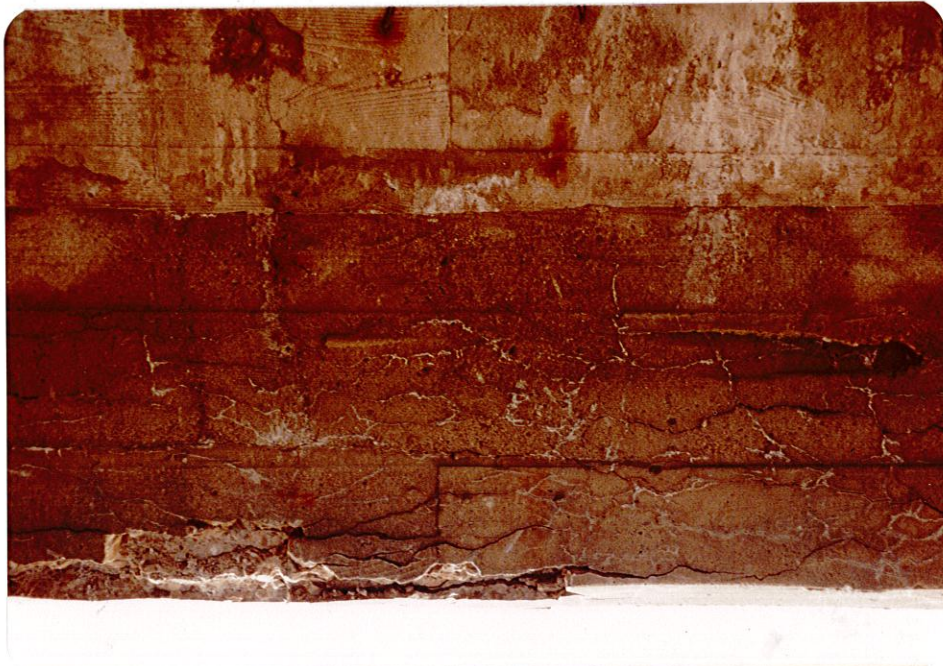
There is serious spalling, delamination and cracking in the beams of the superstructure. There is also considerable evidence of leaching from chlorides. There are four beams in the super-structure of each of the spans. The two outside beams are directly under the concrete headwall handrails. The spalling on the bottom of the downstream side of the westerly outside girder is quite deep as shown in Pictures (iv) and (v). Much of the remaining concrete is delaminated and can be readily chipped away. The inside face of the outside west beam of the second span from the north abutment is shown in Picture (x). The bottom 200 mm of the beam is badly cracked and

BR-476 - (x) - Inside Face of Outside West Beam - Second  
Span from North Abutment

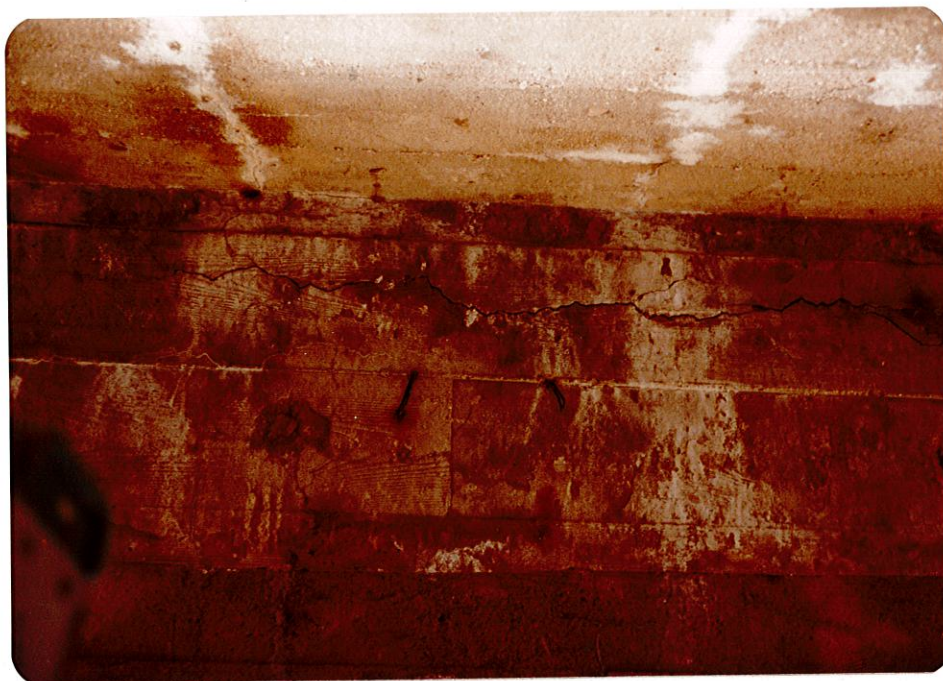
delaminated and could be removed through chipping. Picture (xi) is also of the mid-span of the same beam and shows a serious horizontal stress crack located approximately 150 mm from the underside of the concrete deck slab. There were also places in the other beams where there is spalling, delamination and cracking. Picture (xii) is of the bottom of the first beam west of centreline in the second span from the north abutment. Picture (xiii) shows a serious delamination on the bottom of the east outside girder of the first span from the north abutment while Picture (xiv) shows the bottom of the first beam east of centreline in the first span. In both of the last two mentioned locations, the remaining concrete consisted of loose aggregate which could be readily chipped away.

BR-476 - (xi) - Inside Face of Outside West Beam - Second Span from North Abutment

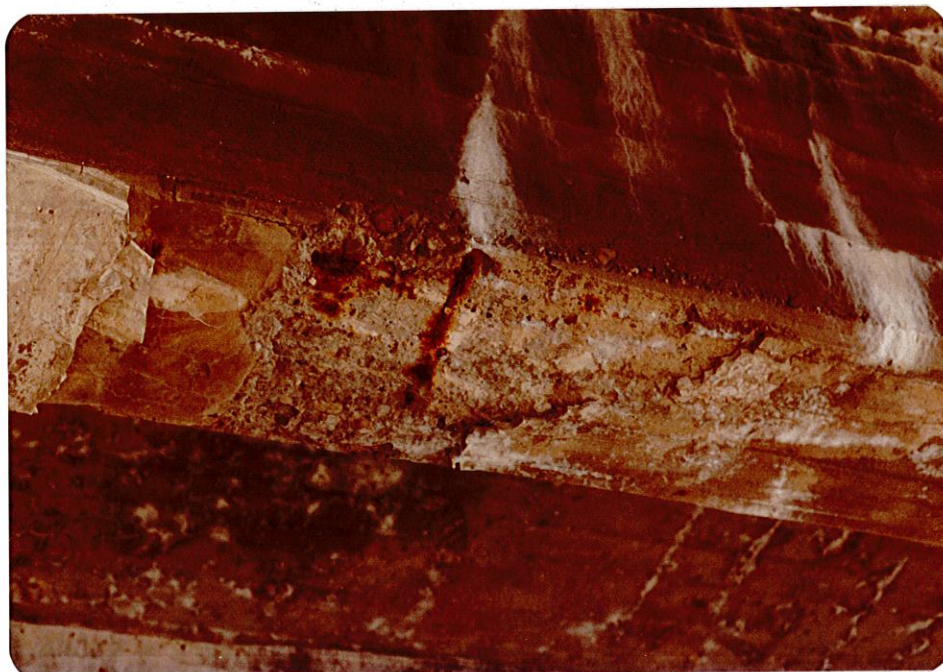
BR-476 - (xii) - Bottom of First Beam West of Centreline - Second Span from North Abutment

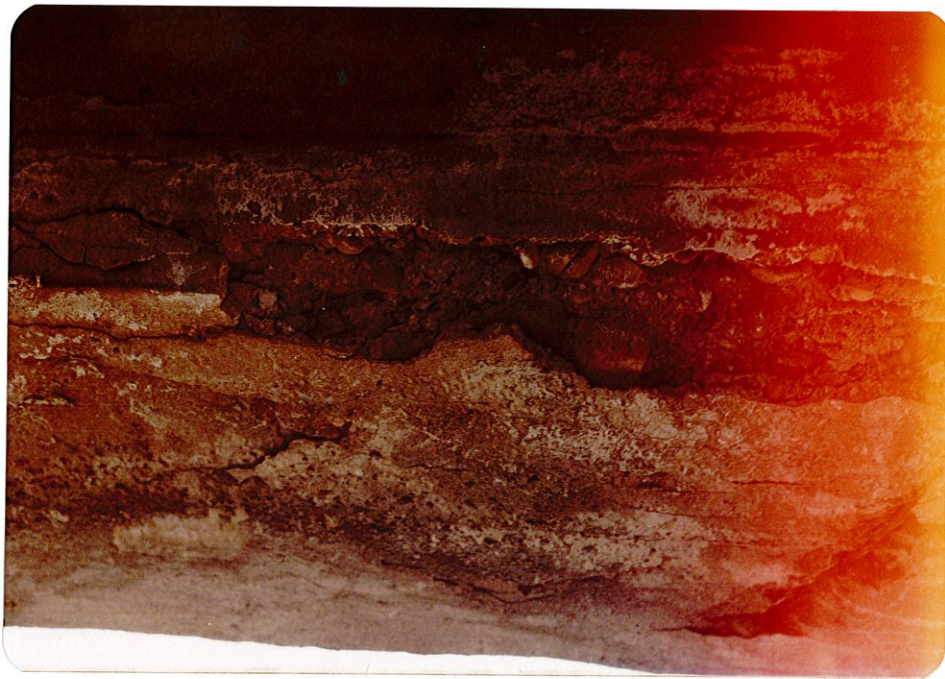
BR-476 - (xiii) - Bottom of Inside Face of East Outside  
Girder - First Span from North Abutment

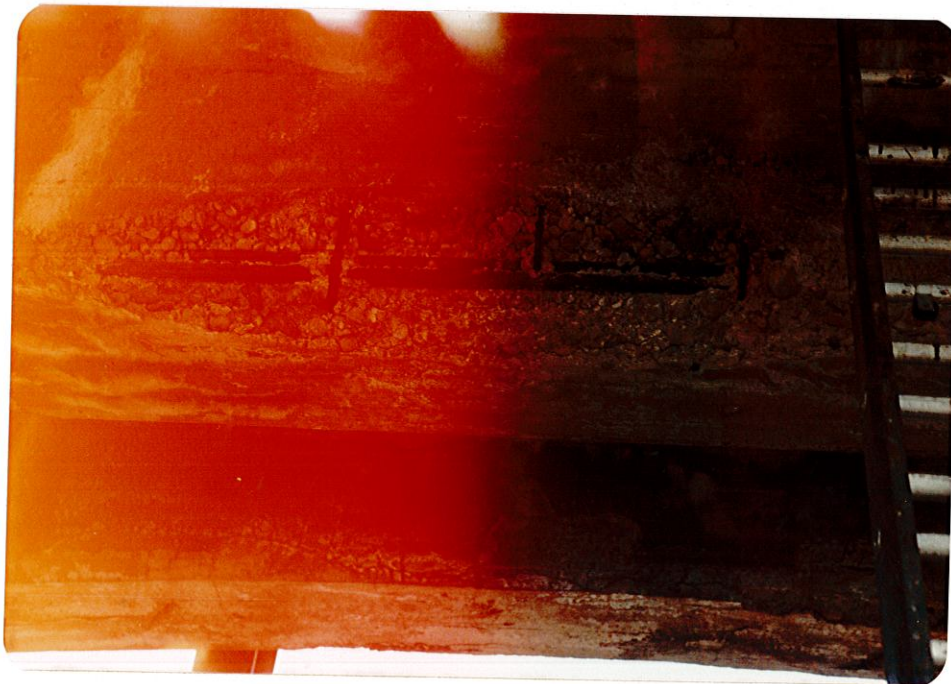
BR-476 - (xiv) - Bottom of First Beam East of Centreline  
- First Span from North Abutment
