SITE VISIT REPORT

North Huron Wescast Community Complex	Project No.: 1550.00
	Date of Visit: 16-December-2015
	Time of Visit: 12:00 PM
	Weather: 3°C Windy, Overcast

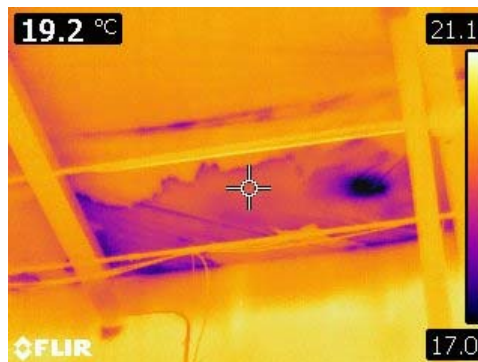
2. Thermographic images were taken at the top of wall and heat loss at the top of the bulkhead was observed. Signs of moisture damage and pooling water above the pinched insulation was also observed. The moisture generally occurs above the purlins for +/-10' at the pool wall.

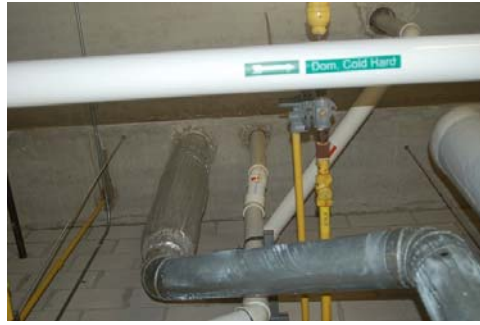
3. Review of the mechanical room penetrations was conducted. Two of the exhaust vents, one from the furnace and one from an HRV was observed with active dripping of water.

Postscript: It is unclear from review of the tender documents if the HRV or furnace is original. From review of the construction photos it appears that the gooseneck and stack were installed between 2010 and 2015.

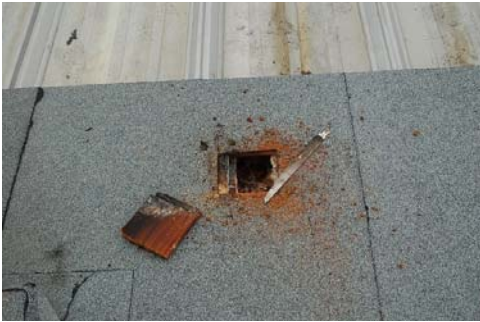
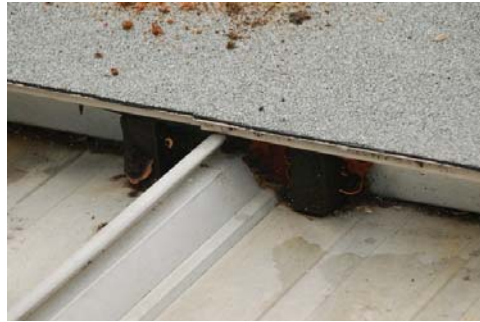
4. Cut 1: location at the bottom of the 2-ply roof. The plywood sheathing is wet and rotting. Two exposed 2x4 framing members extend from below the roof and appear to be wicking water up below the roof. The bottom of the roof area does not align with a 'Z' girt and the metal roofing deflects and may allow wind driven rain or snow to enter.

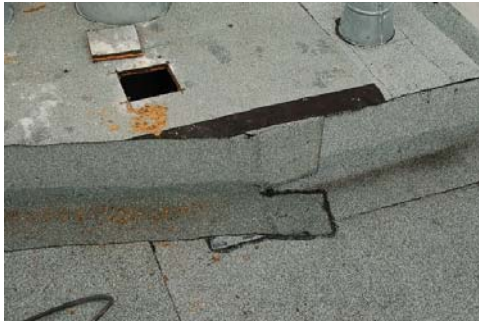
Curb Cut No. 4

7. Cut 4: Through the curb at the stacks. Thermographic images show a high heat loss at the stacks. The curb is not original to the work completed by Smith Peat and is verified by photos from 2010. The curb was added and the insulation at the 2-ply roof was removed. A +/- 18" dia. Hole was cut in the metal roof below and the existing spray polyurethane foam insulation was removed. The air temperature within the curb was observed at 20°C. The air from the mechanical room and pool is condensing on the underside of the concrete deck and on the exhaust vents and dripping into the mechanical room and is not a result of a penetration through the roofing membrane.

8. During the review the relative humidity at the pool was 71. With an air temperature of 24°C dewpoint will occur at 18°C. The structural steel beams above the pool will not be kept warm enough to not condensate. Review of the mechanical systems to reduce the relative humidity will be conducted.
9. Conclusion: The bottom of the 2-ply roofing should be extended to align with a Z-girt and the rotten framing and sheathing removed and disposed of. The curb at the exhaust vents should also be opened and spray polyurethane foam insulation applied between the vent and concrete deck. The curb should also be filled with mineral wool insulation to prevent condensation due to the exhaust vents within the curb.
