Annual Activities Review

The Township of North Huron Water and Wastewater Operations and Maintenance Summary 2017 Presented by Veolia Water

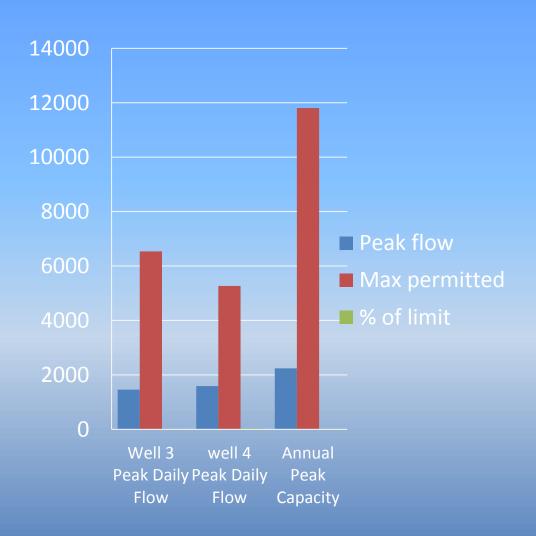
Wingham Water Taking 2017 Cubic Meters

- Permit to take water permits a max daily flow :
 - Well 3: 6537m3/dayWell 4: 5270m3/day
 - Total: 11807m3/day
 - Well 3: 1454m3 (22.2%)

- Well 4: 1584m3 (30.1%)
- Max daily flow: 2241m3 (19%)

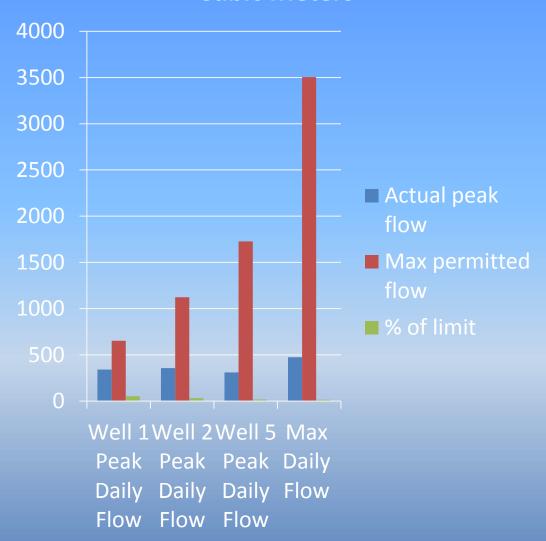
Blyth Water Taking 2017 Cubic Meters

- Permit to take water permits a max daily flow :
 - Well 1: 653m3/day
 - Well 2: 1123m3/day
 - Well 5: 1728m3/day
 - Total: 3504m3/day
- Peak flows for 2017:
 - Well 1: 341m3 (52.2%)
 - Well 2: 356m3 (31.7%)
 - Well 5: 310m3 (17.9%)
 - Max daily flow: 474m3 (13.5%)
